INDOOR AIR QUALITY ASSESSMENT

**Holbrook Junior/Senior High School
245 South Franklin Street
Holbrook, MA 02343**

Prepared by:
Massachusetts Department of Public Health
Bureau of Environmental Health
Indoor Air Quality Program
March 2008

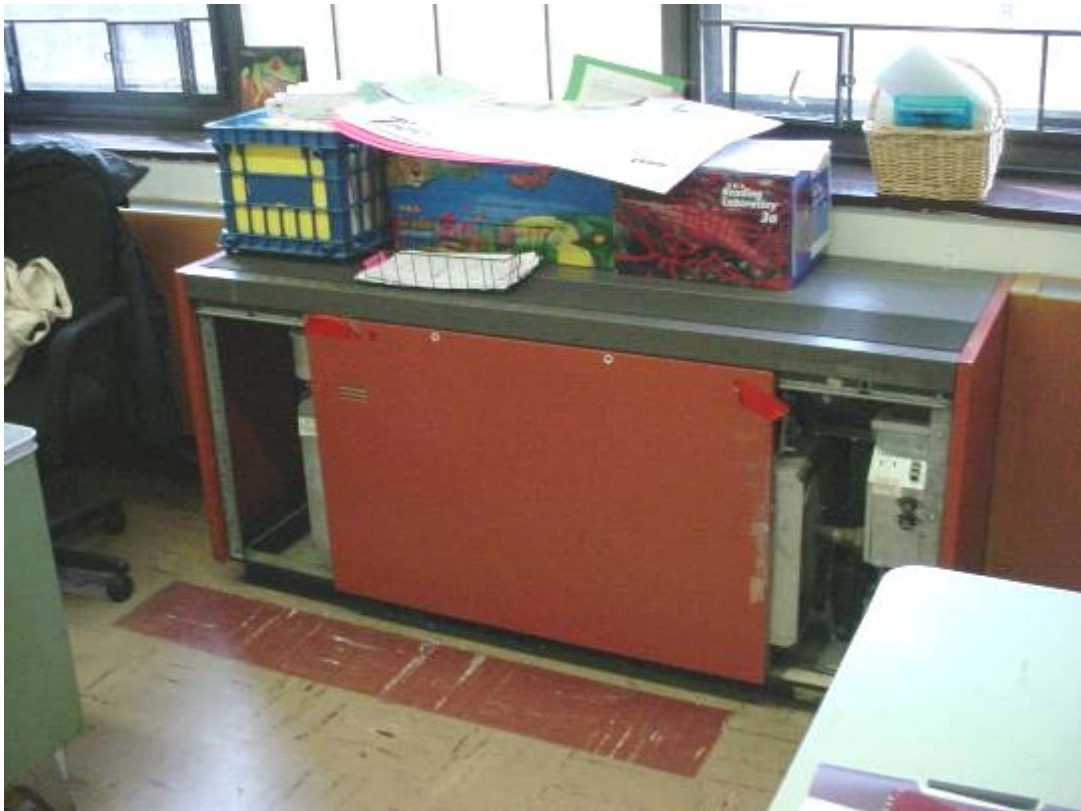
Picture 1

Fresh air is supplied to classrooms by unit ventilator (univent) systems (Pictures 1 and 2). A univent draws air from the outdoors through a fresh air intake located on the exterior wall of the building (Picture 3) or rooftop (Picture 4) and returns air through an air intake located at the base of the unit ([Figure 1](#)). Fresh and return air are mixed, filtered, heated and provided to classrooms through an air diffuser located in the top of the unit. Univents have control settings of off, low or high (Picture 5). Univents were found deactivated in many areas; therefore there was no means to provide mechanical ventilation to classrooms at the time of the assessment. Univents were also found obstructed by various items or had missing panels, exposing the interior of the units. In one instance (Room 112), the univent air diffuser was sealed with sheet metal (Picture 6). In order for univents to provide fresh air as designed, intakes/returns must remain free of obstructions. Importantly, these units must remain “on” and be allowed to operate while rooms are occupied.

Classroom Univent, Note Missing Panels

2. Replacing missing univent cabinet panels.
3. Operate all ventilation systems throughout the building (e.g., gym, locker rooms, cafeteria, classrooms) continuously during periods of school occupancy and independent of thermostat control. To increase airflow in classrooms, set univent controls to “high”.

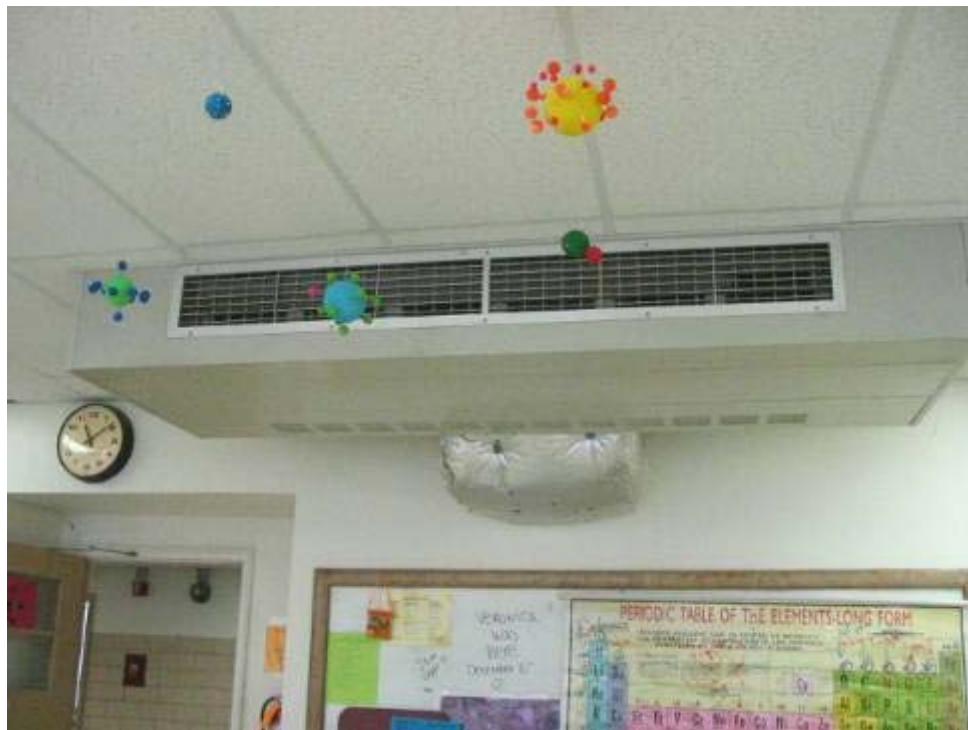
Picture 2

Ceiling-Mounted Univent

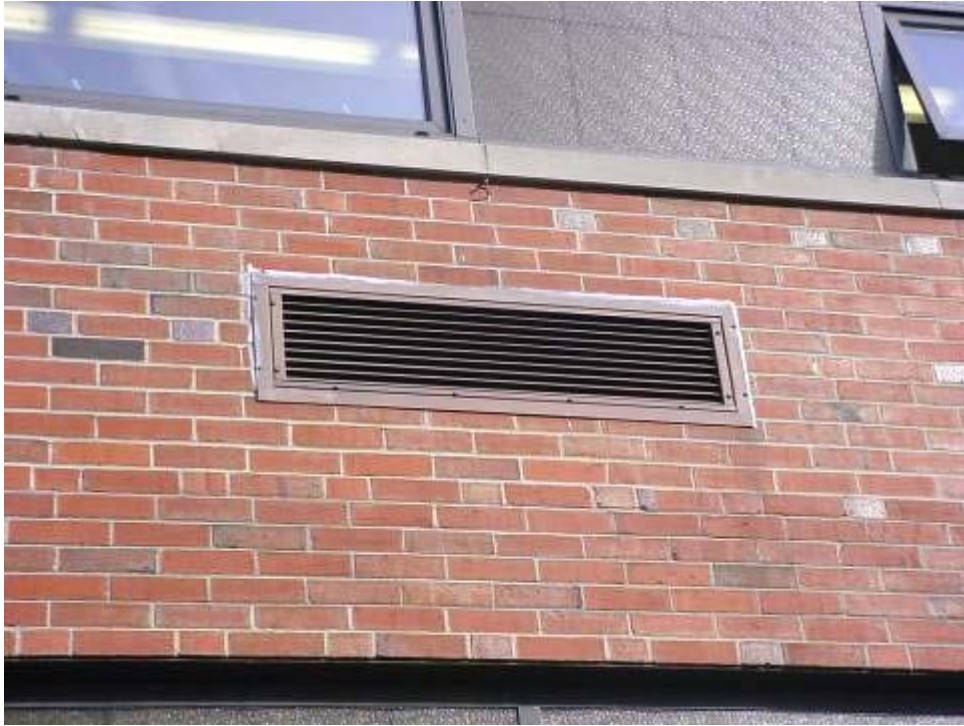
Picture 3

Univent Fresh Air Intake Exterior Wall

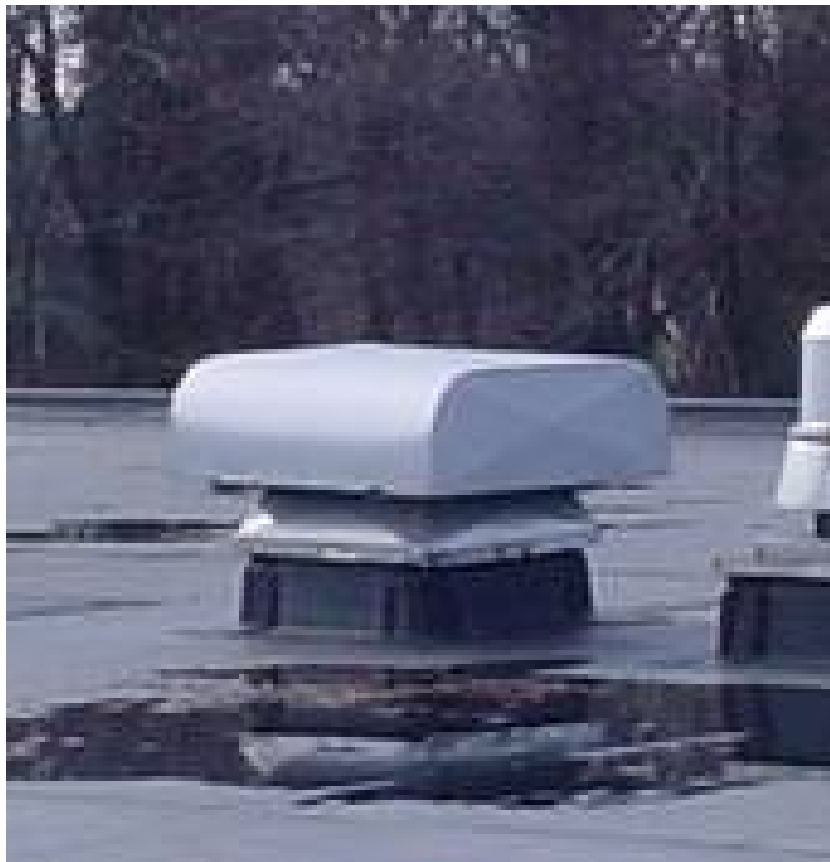
Picture 4

Rooftop Univent Fresh Air Intake for Interior Room

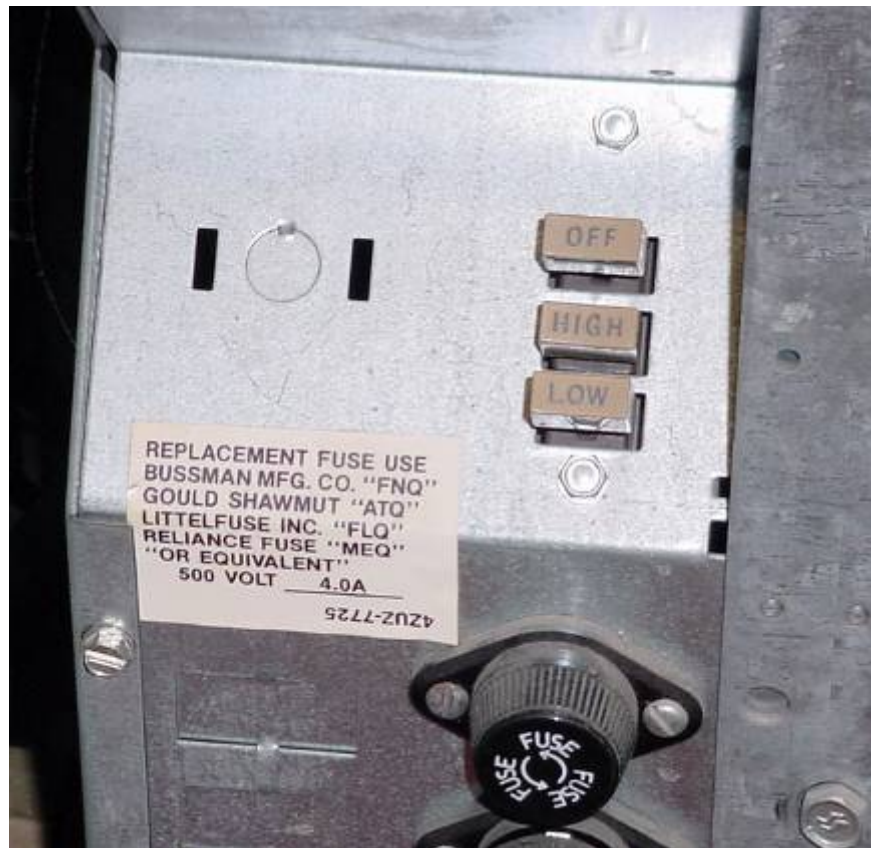
Picture 5

Univent Control Switches Found in Interior of Cabinet

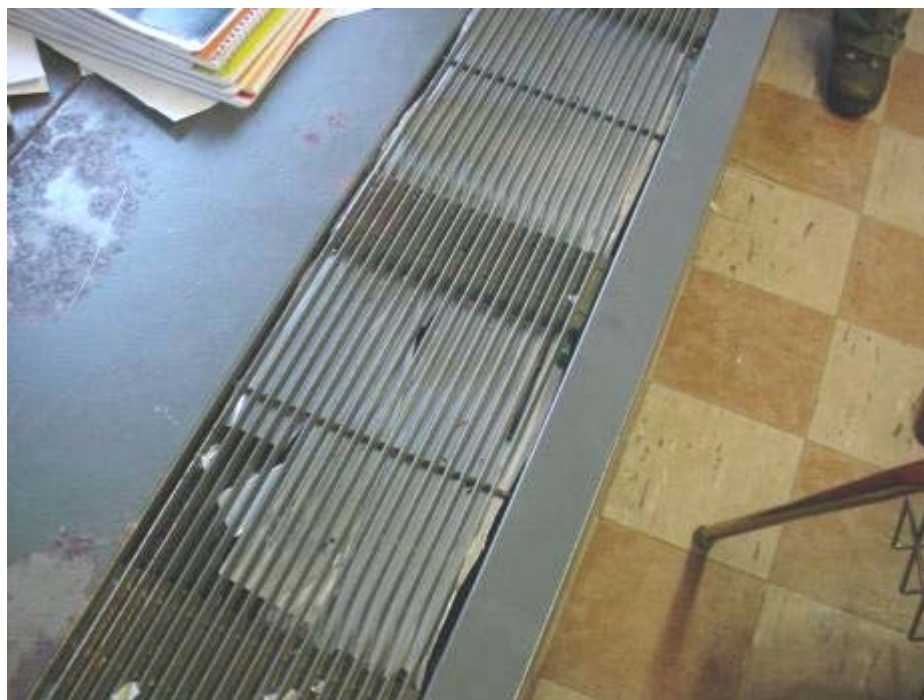
Picture 6

Univent Air Diffuser Sealed with Sheet-Metal

4. Inspect exhaust motors and belts for proper function. Repair and replace as necessary.
5. Remove all blockages from univents (e.g., sheet metal/Picture 6) and exhaust vents to ensure adequate airflow.

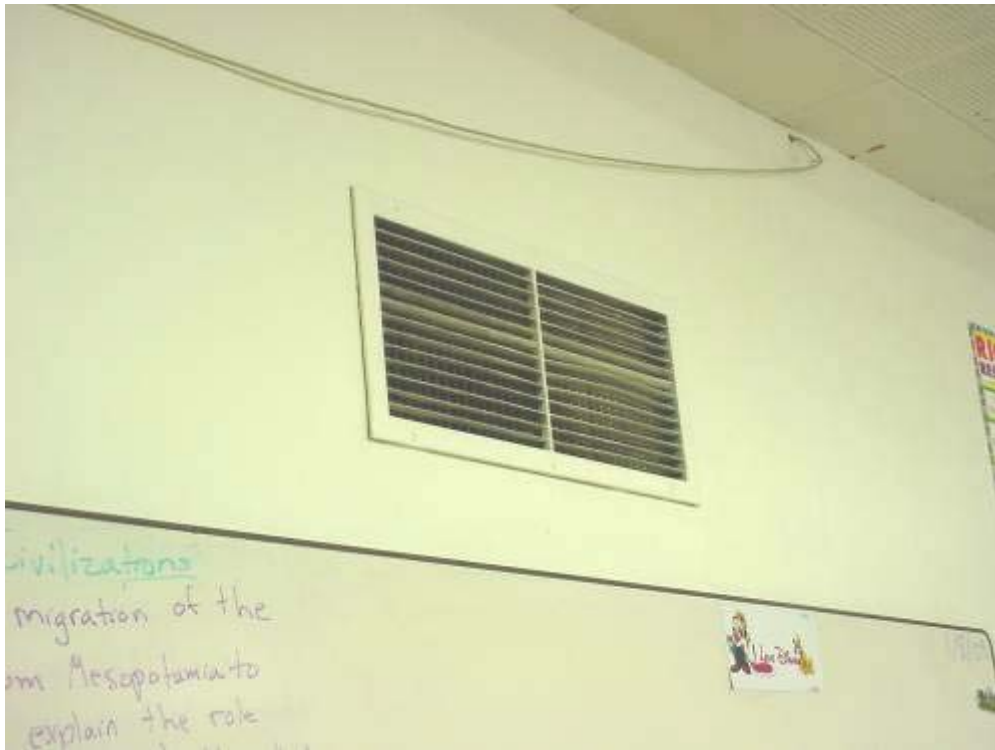
Picture 7

Exhaust ventilation in classrooms is provided by wall or ceiling vents ducted to rooftop motors (Pictures 7 and 8). Many exhaust vents were deactivated at the time of the assessment. As with univents, in order to function properly, exhaust vents must be activated and allowed to operate while rooms are occupied. Without adequate supply and exhaust ventilation, excess heat and environmental pollutants can build up and lead to indoor air/comfort complaints.

Wall-Mounted Exhaust Vent

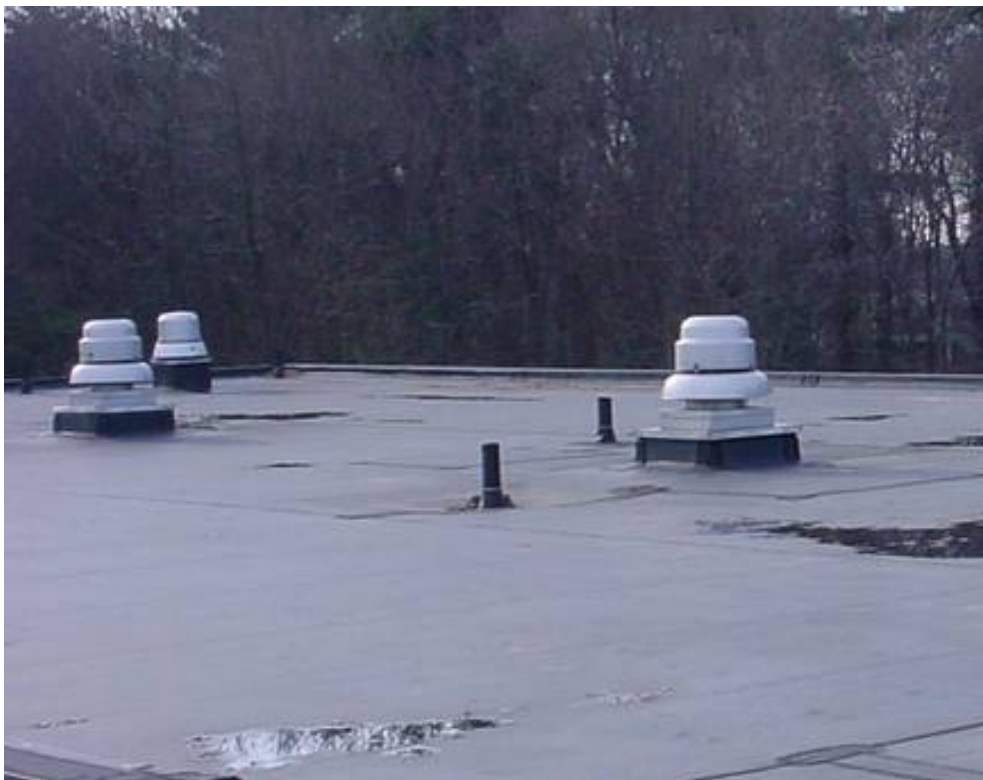
Picture 8

Rooftop Exhaust Motors

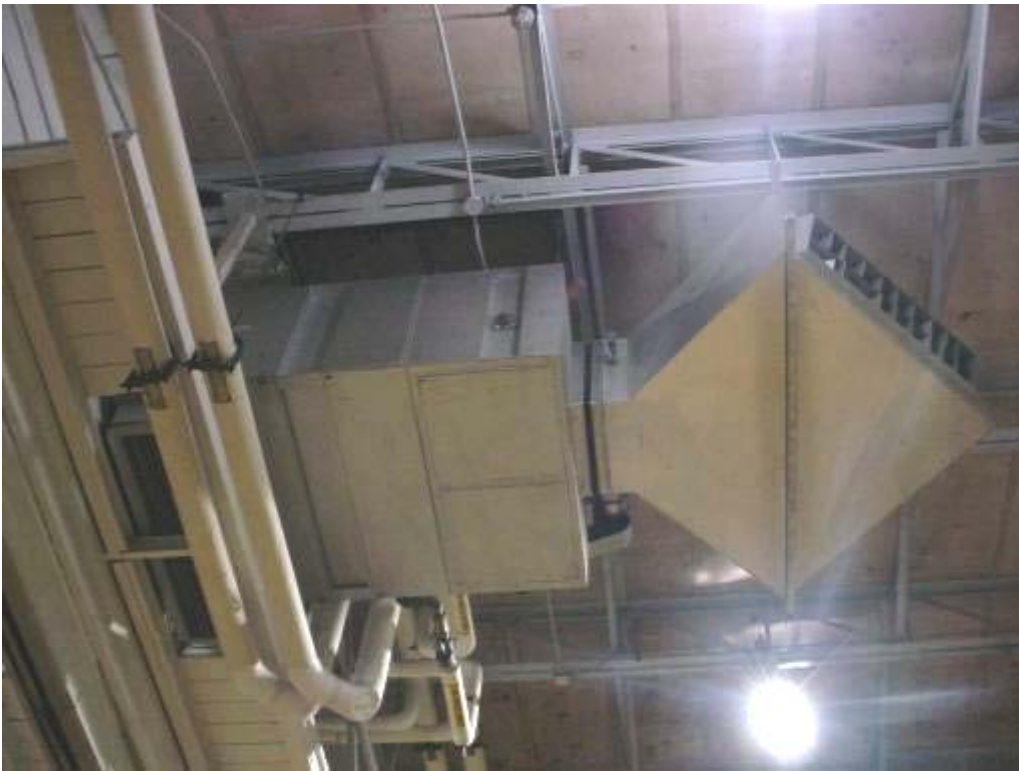
Picture 9

Mechanical ventilation in common areas (e.g., gym, locker rooms, auditorium and cafeteria) is provided by rooftop or ceiling-mounted air-handling units (AHUs). Fresh air is distributed via ceiling-mounted air diffusers and ducted back to AHUs via return vents at the base of the units (Pictures 9 and 10). These units were deactivated at the time of the

assessment; therefore, there were no means of mechanical air exchange which was evidenced by the elevated carbon dioxide levels in the gym (952 ppm).

Ceiling-Mounted Air Handling Unit in Gym (One of Four)

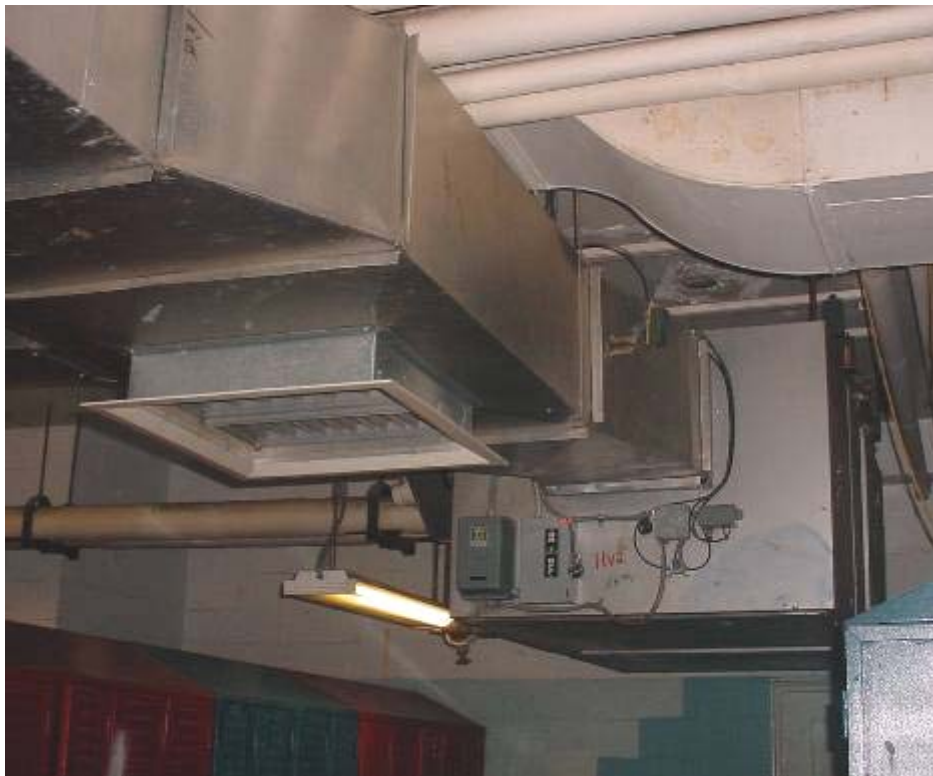
Picture 10

Deactivated AHU in Locker Room

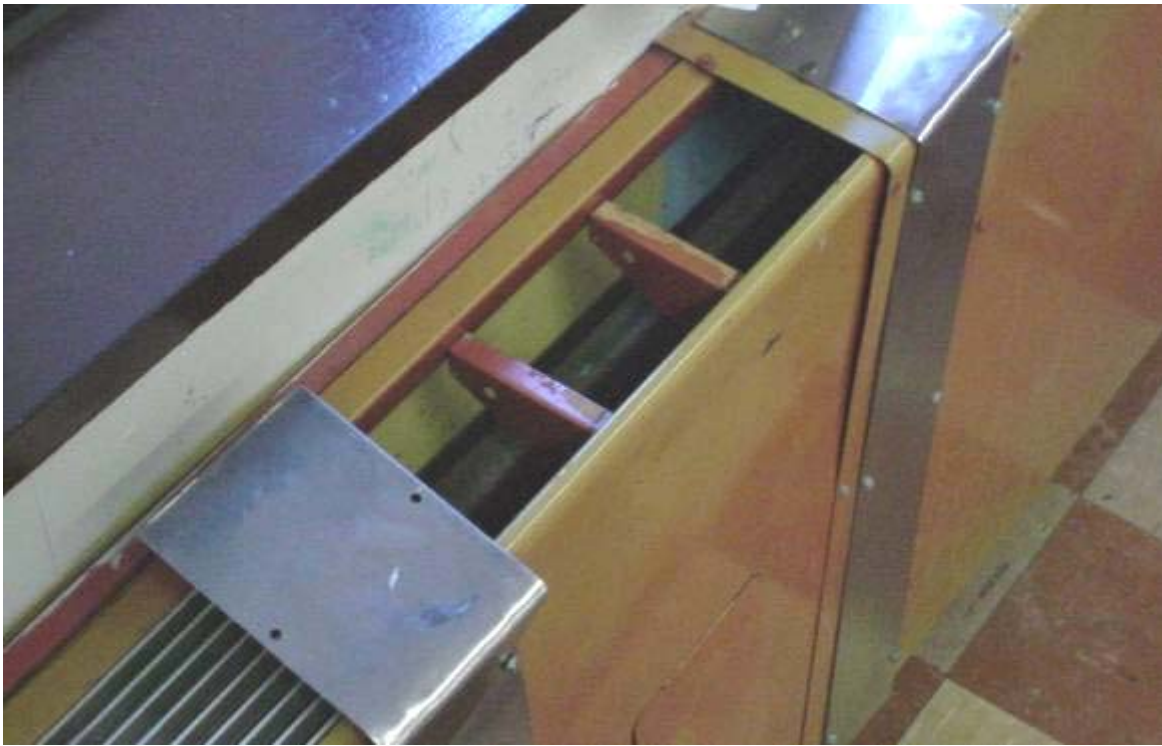
Picture 11

Temperature measurements ranged from 69° F to 75° F, which were within the MDPH recommended comfort range in the majority of areas surveyed. The MDPH recommends that indoor air temperatures be maintained in a range of 70° F to 78° F in order to provide for the comfort of building occupants. In many cases concerning indoor air quality, fluctuations of temperature in occupied spaces are typically experienced, even in a building with an adequate fresh air supply. In addition, it is difficult to control temperature and maintain comfort without operating the ventilation equipment as designed (e.g., univents/exhaust vents deactivated/obstructed). Missing radiator grates were observed in classroom 112 (Picture 11), which can create uneven heating and/or a safety hazard.

Missing Grates to Radiator System along Exterior Wall in Classroom 112

8. Replace/repair missing/damaged radiator baseboard cover in classroom 112 (Picture 11).
9. Ensure chemical exhaust hoods in science areas are operating properly. Science staff should work with school administration and their HVAC vendor to develop a preventative maintenance program for all local exhaust equipment (e.g., lab hoods, prep rooms).

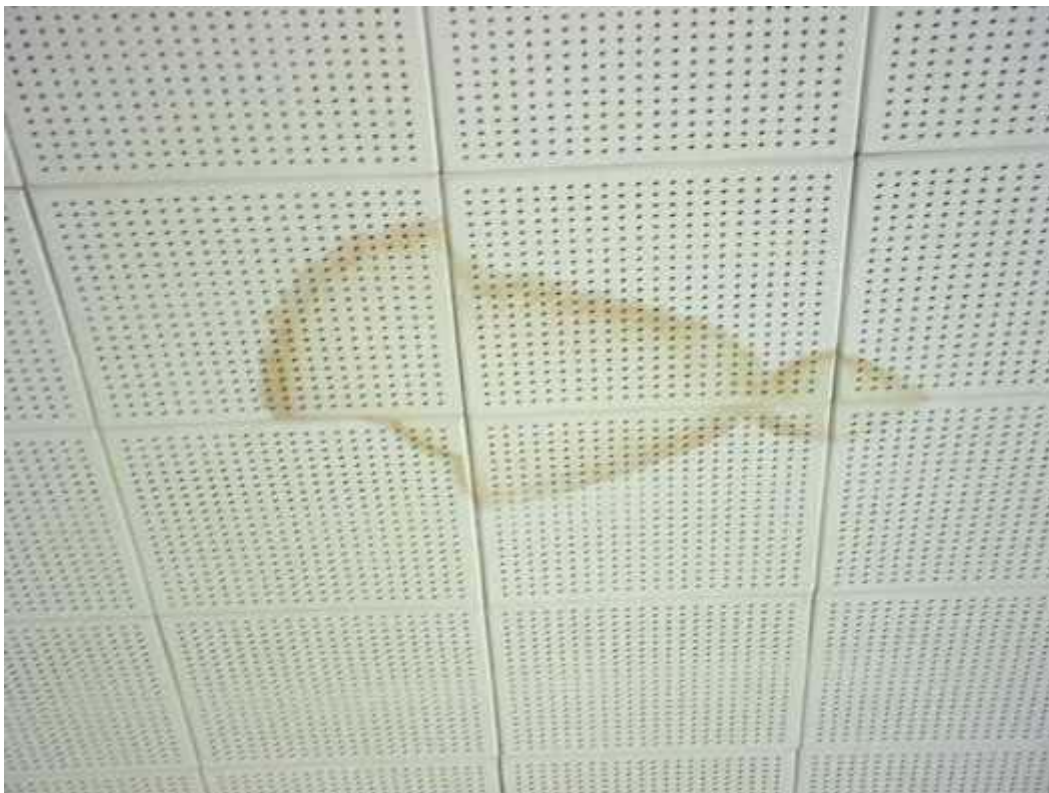
Picture 12

Several potential sources of water damage and mold growth were observed. Numerous areas had water-damaged/missing ceiling tiles which can indicate leaks from either the roof or plumbing system (Pictures 12 and 13/Table 1). Active leaks were reported along windows in room 112. In many areas, ceiling tiles have been completely removed or are loose/hanging creating physical hazards (Pictures 13 through 15). Water-damaged ceiling tiles can provide a source of mold and should be replaced after a water leak is discovered and repaired.

Water Damaged Ceiling Tiles

12. Ensure roof/window leaks are repaired and remove/replace any remaining water-stained ceiling tiles.
13. Remove all loose/hanging ceiling tiles to prevent falling hazards.

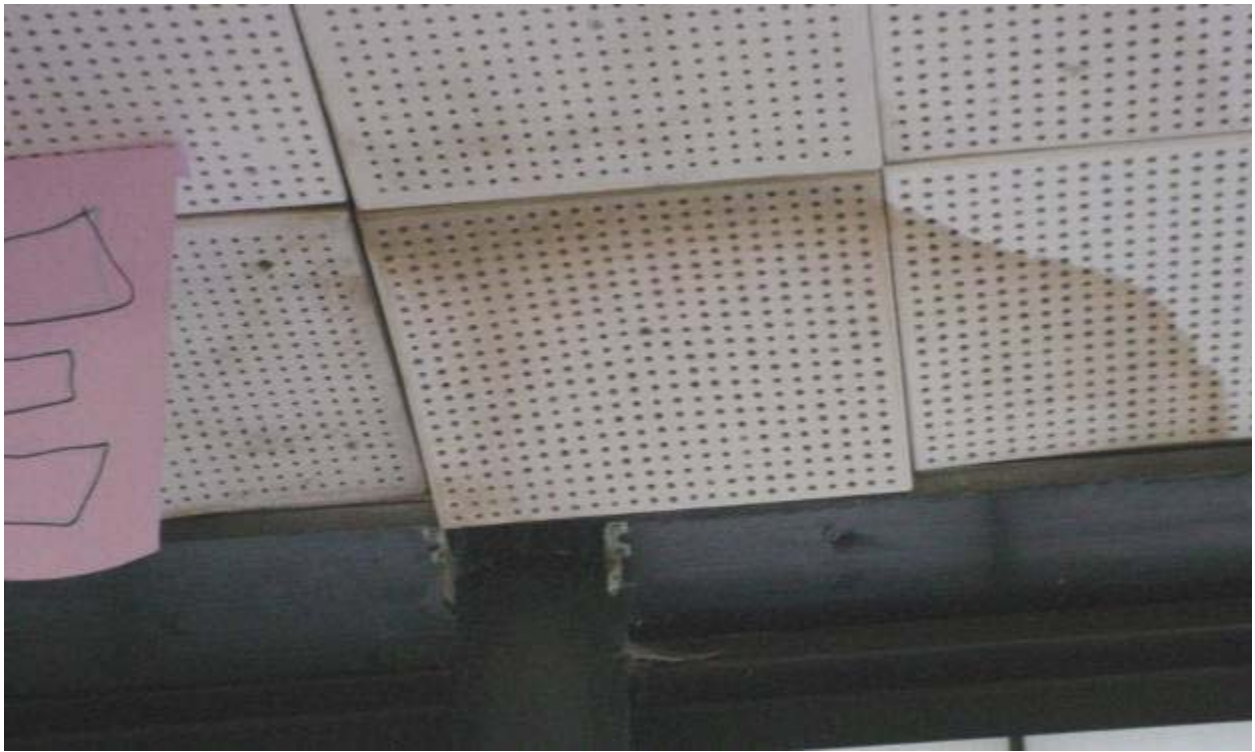
Picture 13

Water Damaged/Loose Ceiling Tiles along Exterior Wall/Window System

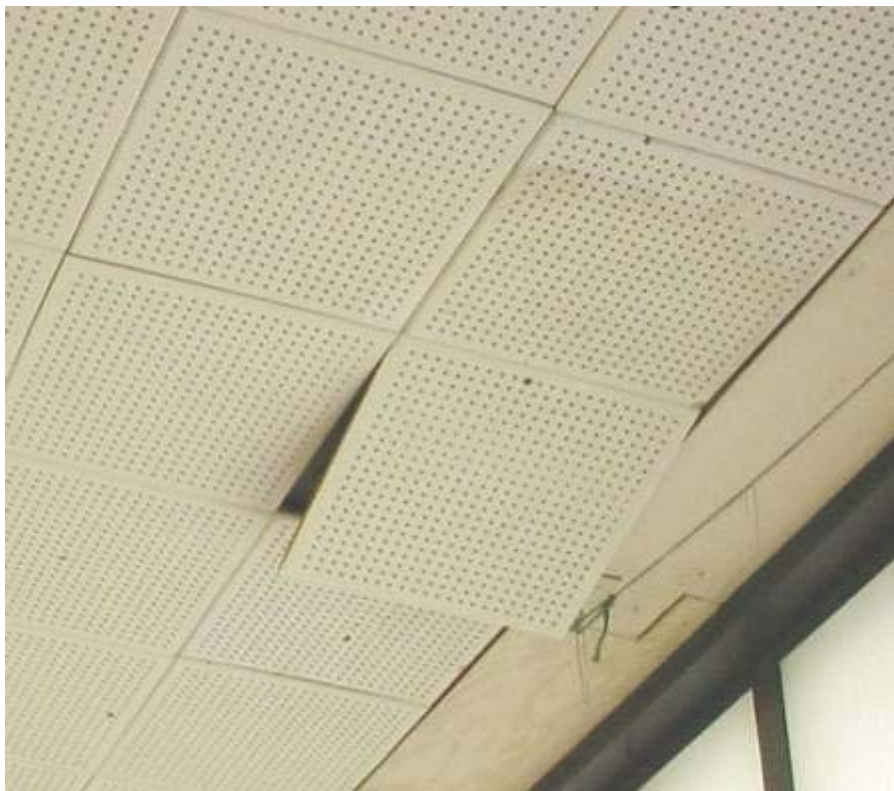
Picture 14

Water Damaged Ceiling Tiles, Note Hanging Tile

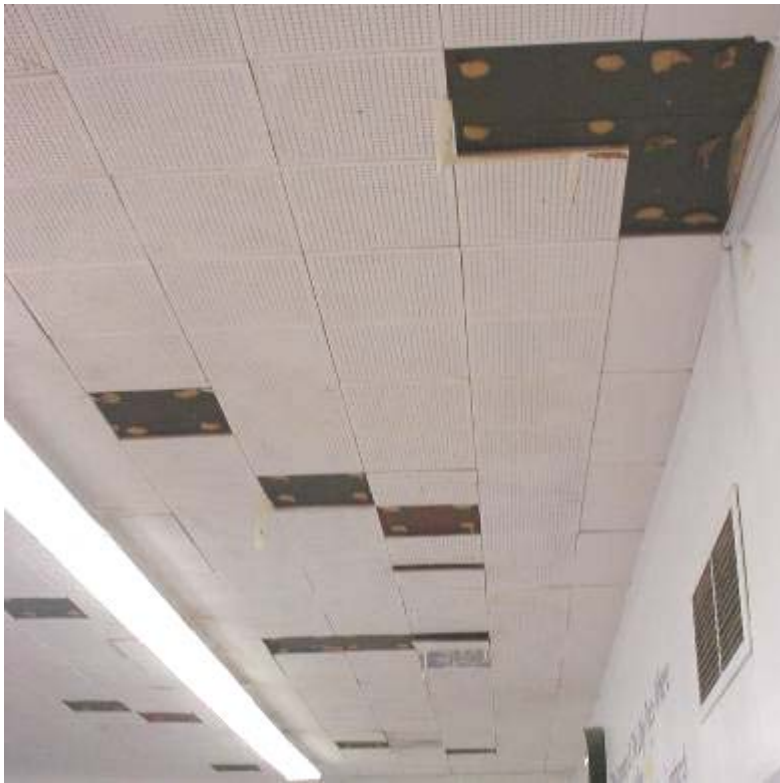
Picture 15

Numerous Missing/Water Damaged Ceiling Tiles in Classroom

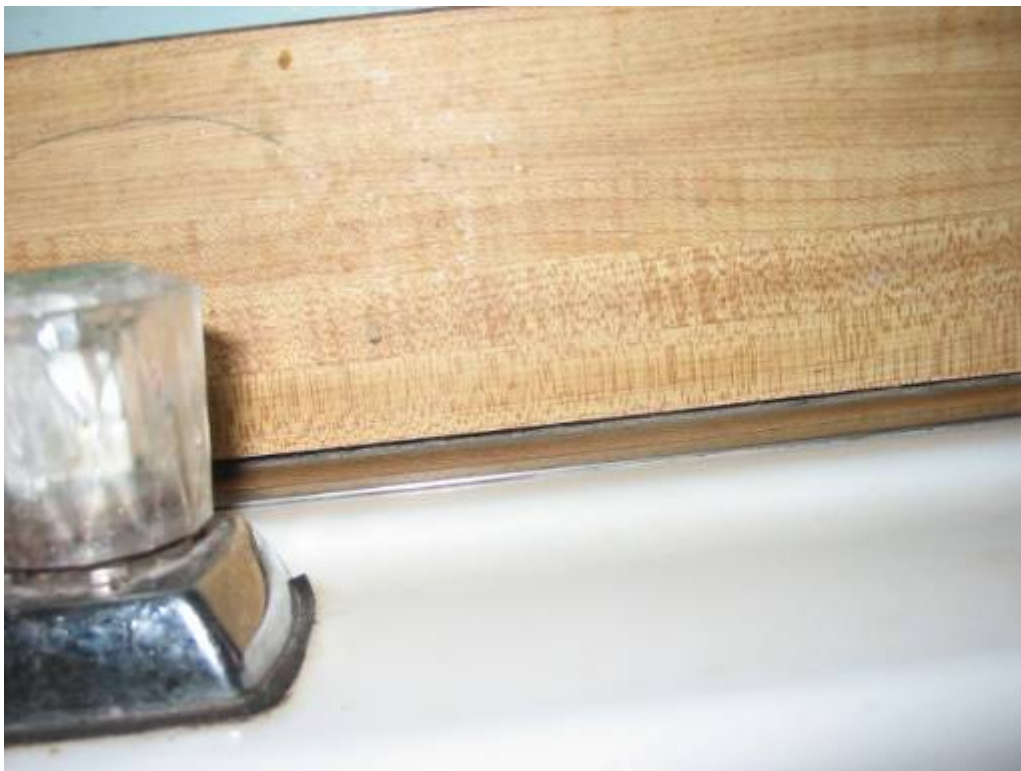
Picture 16

Open seams between sink countertops and walls were observed in several rooms (Picture 16/Table 1). If not watertight, moisture can penetrate through the seam, causing water damage. Improper drainage or sink overflow can lead to water penetration into the countertop, cabinet interior and areas behind cabinets. Water penetration and chronic exposure of porous and wood-based materials can cause these materials to swell and show signs of water damage.

Open Seam between Sink and Wall

15. Seal areas around sinks to prevent water damage to the interior of cabinets and adjacent wallboard. Inspect wallboard for water damage and mold growth, repair/replace as necessary. Disinfect areas with an appropriate antimicrobial, as needed.

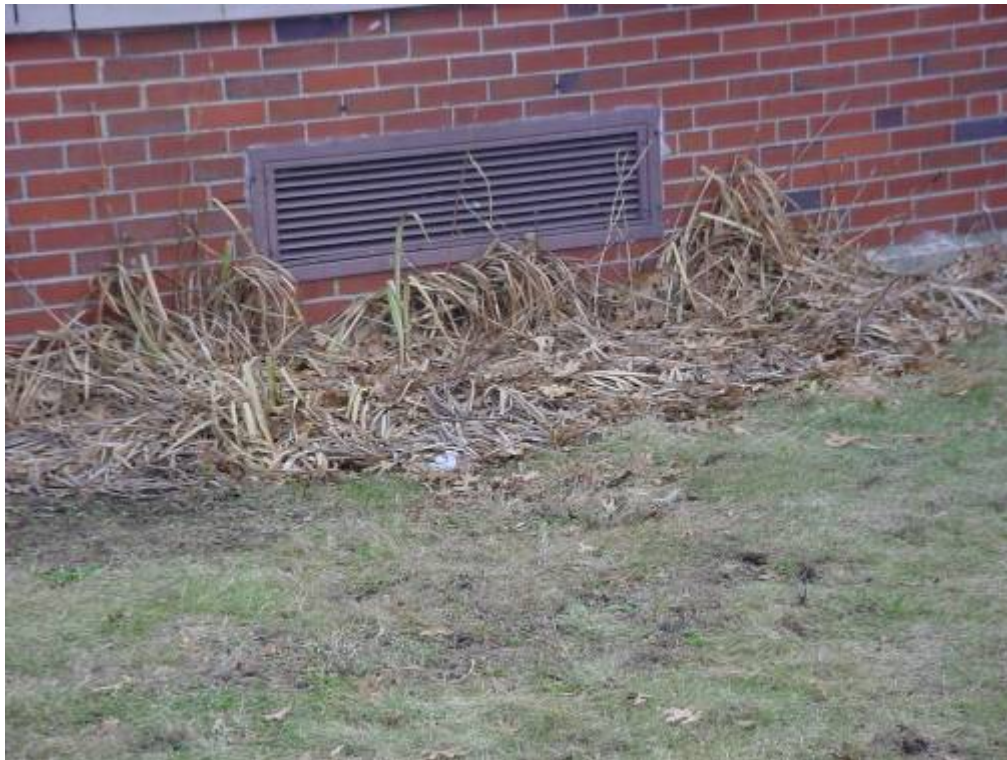
Picture 17

Plants were observed growing in close proximity to a univent fresh air intake along the exterior (Picture 17). Shrubbery and flowering plants can be sources of mold and pollen and should be located away from fresh air intakes to prevent entrainment.

Plants Growing in front of Univent Fresh Air Intake

14. Move plants along the exterior of univent air intakes approximately 5-feet to prevent entrainment of pollen, moisture or mold.

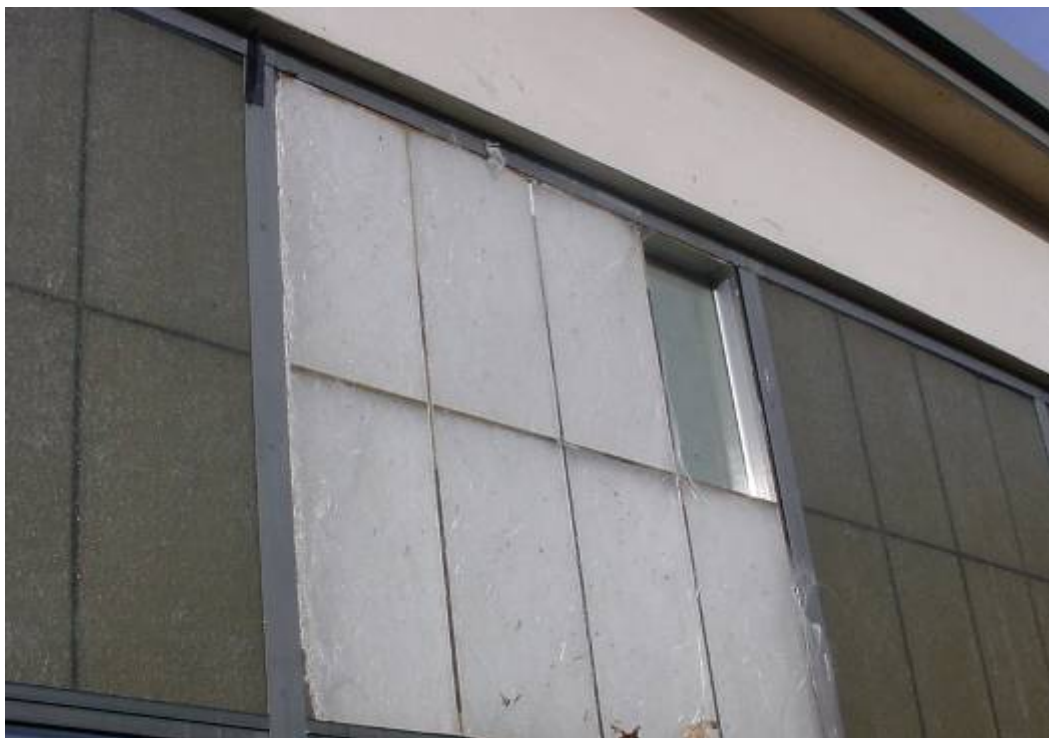
Picture 18

Also noted on the exterior of the building were missing panels (Picture 18), damaged brickwork and missing/damaged mortar around masonry (Pictures 19 and 20). Freezing/thawing action during winter months can further weaken bricks and mortar. Over time, this process can undermine the integrity of the building envelope, providing a means of water entry into the building via capillary action through foundation concrete and masonry (Lstiburek & Brennan, 2001).

**Missing/Damaged Wall Panels along Rear Exterior of Building (Center)
Exposing a Fibrous Mesh Material (Compare to Right and Left)**

16. Replace/repair missing/damaged exterior wall panels (Picture 18).
17. Contact a masonry firm or general contractor to repair holes/breaches in exterior walls to prevent water penetration, drafts and pest entry.

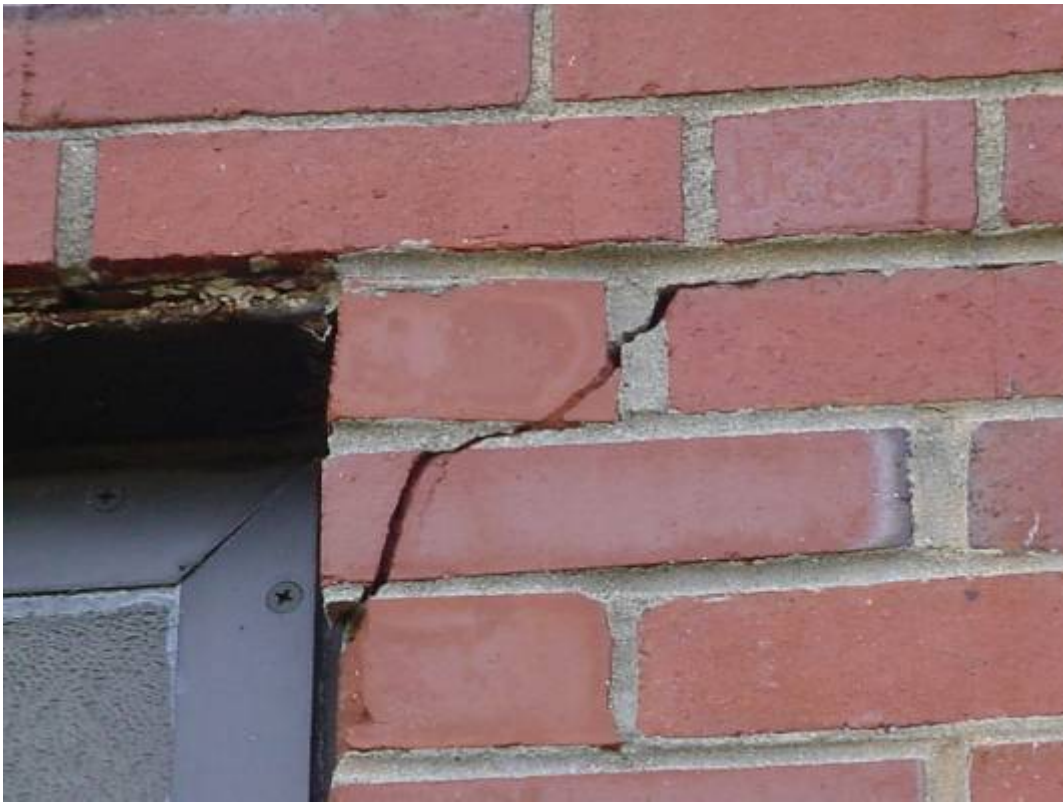
Picture 19

Damaged Brickwork

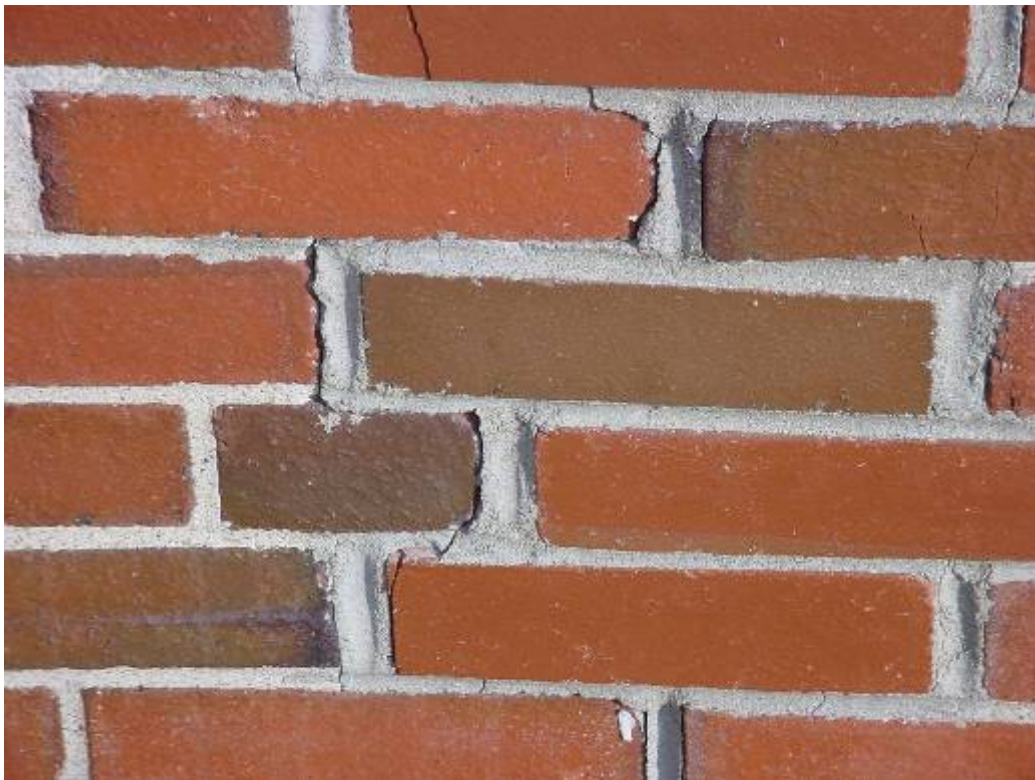
Picture 20

Missing/Damaged Mortar around Brickwork

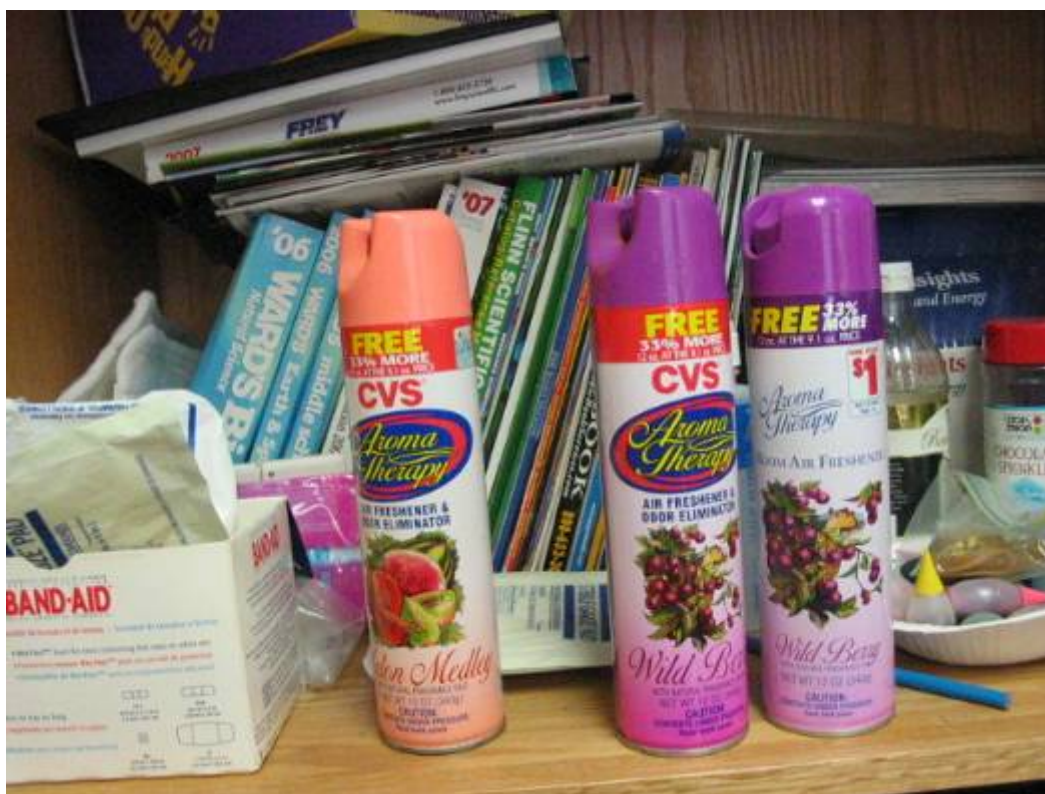
Picture 21

Air fresheners and other scented materials (i.e., fragrant candles) were observed in some areas (Pictures 21 and 23). Air fresheners and candles can contain chemicals that can be irritating to the eyes, nose and throat of sensitive individuals. Furthermore, deodorizing agents do not remove materials causing odors, but rather mask odors that may be present in the area.

Accumulated Items and Spray Air Fresheners

24. Refrain from using air fresheners and deodorizers to prevent exposure to VOCs.
25. Unseal eyewash station; flush out weekly or as recommended by the manufacturer (ANSI, 2004). Work with science staff/Department Head in developing a preventative maintenance program for emergency showers and eye wash stations.

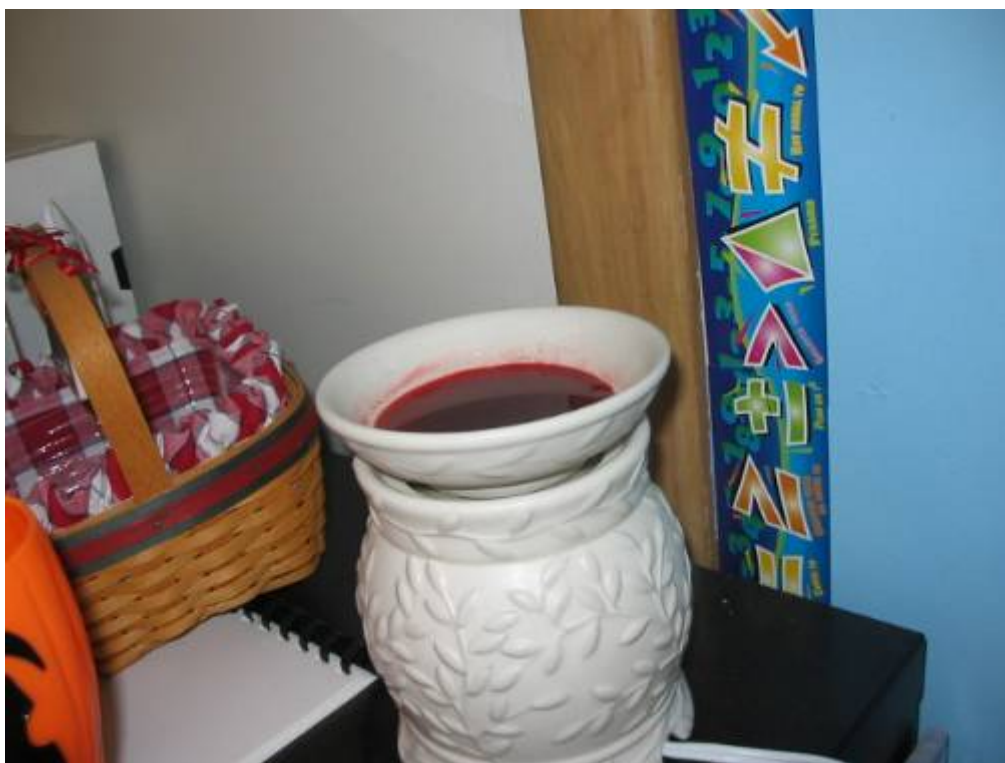
Picture 22

Air Deodorizer

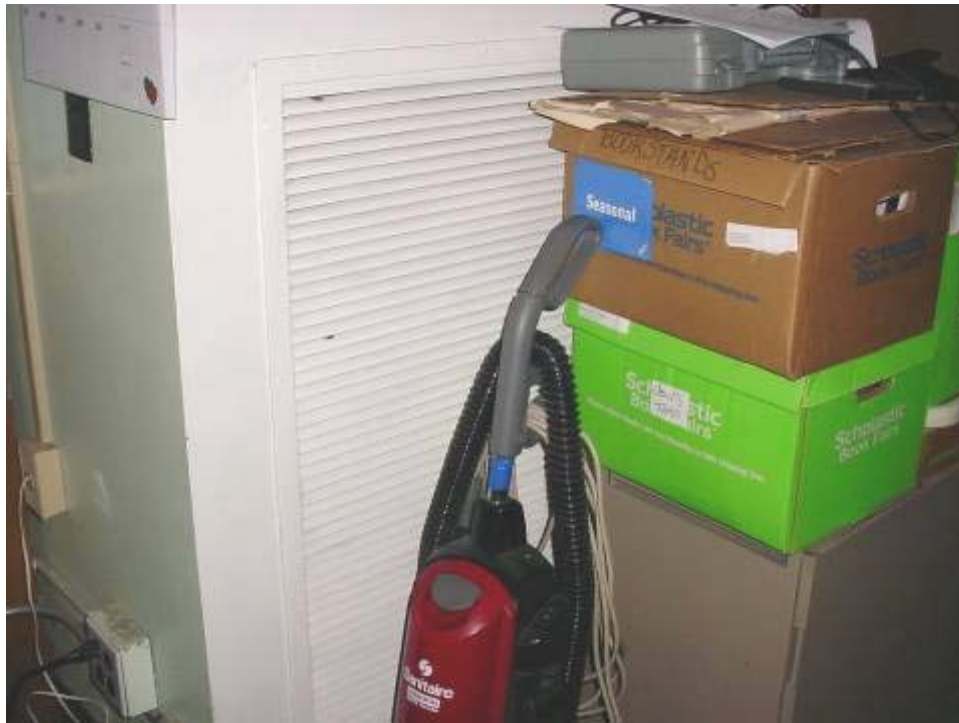
Picture 23

Other conditions that can affect indoor air quality were observed during the assessment. In several classrooms, items were observed on the floor, windowsills, tabletops, counters, bookcases and desks (Pictures 23 through 25). The large number of items stored in classrooms provides a source for dusts to accumulate. These items (e.g., papers, folders, boxes) make it difficult for custodial staff to clean. Items should be relocated and/or be cleaned periodically to avoid excessive dust build up. In addition, these materials can accumulate on flat surfaces (e.g., desktops, shelving and carpets) in occupied areas and subsequently be re-aerosolized causing further irritation.

Accumulated Items

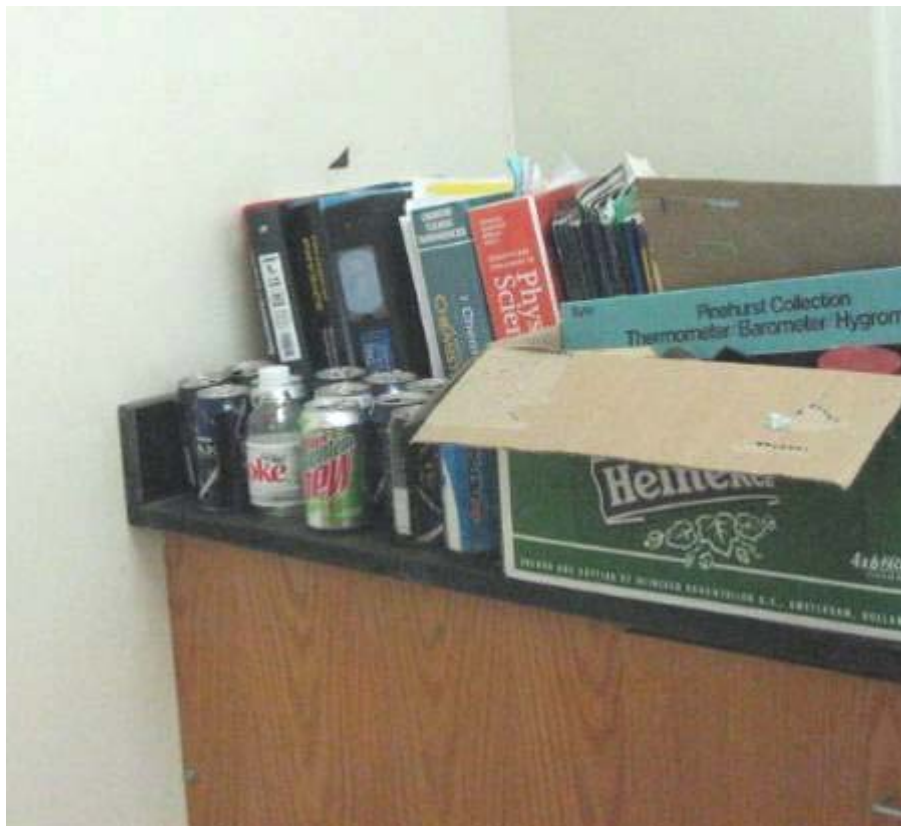
Picture 24

Accumulated Items

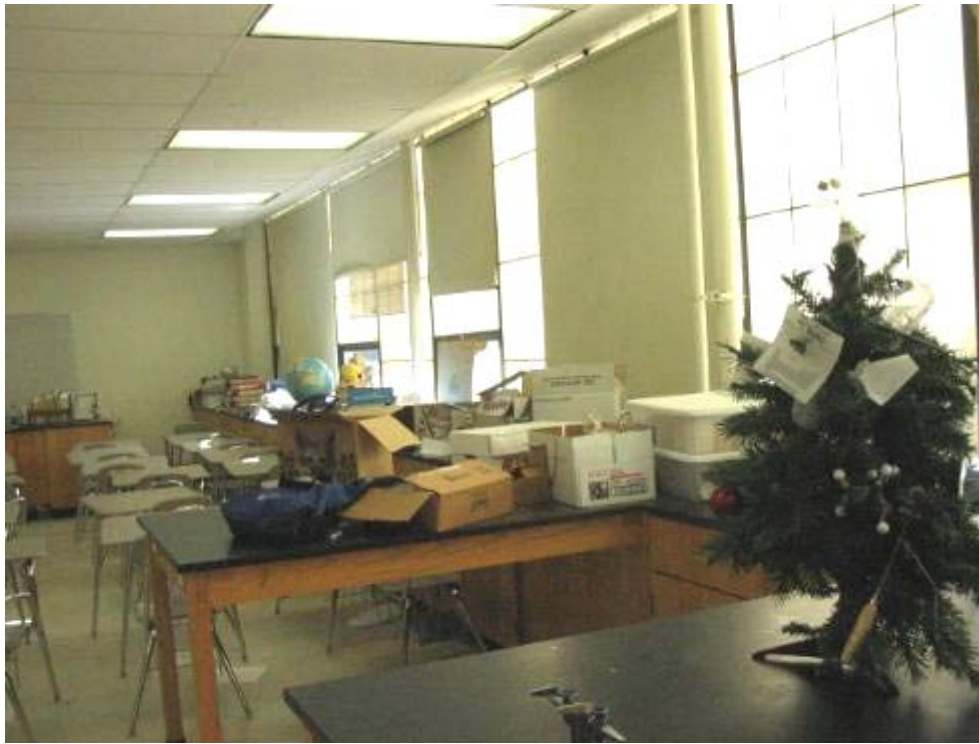
Picture 25

Accumulated Items

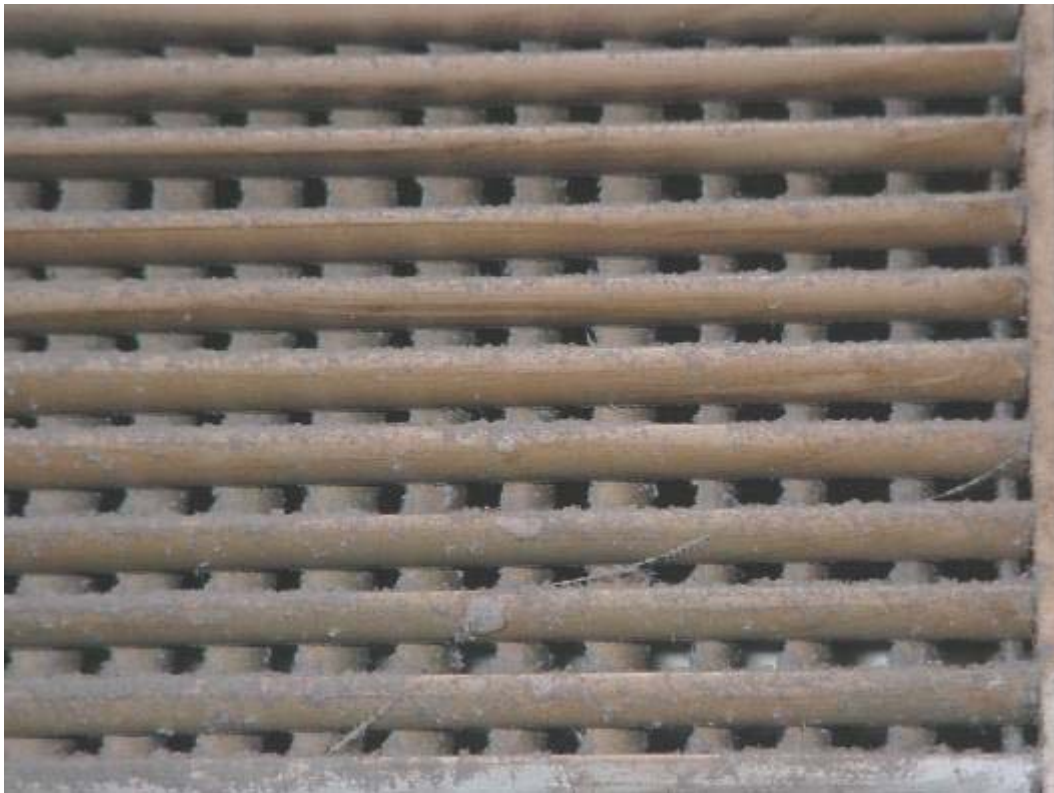
Picture 26

A number of exhaust/return vents, univent supply vents and personal fans (Picture 26 and 27) were observed to have accumulated dust. If exhaust vents are not functioning, backdrafting can occur, which can re-aerosolize accumulated dust particles. Re-activated univents and fans can also aerosolize dust accumulated on vents/fan blades.

Accumulated Dust/Debris on Exhaust Vent
